MAINTENANCE INSTRUCTIONS FOR BVG AERATORS

The purpose of this document is to outline the steps required to inspect and properly torque an aerator cone (BVG207A) from a BVG style outlet gate.

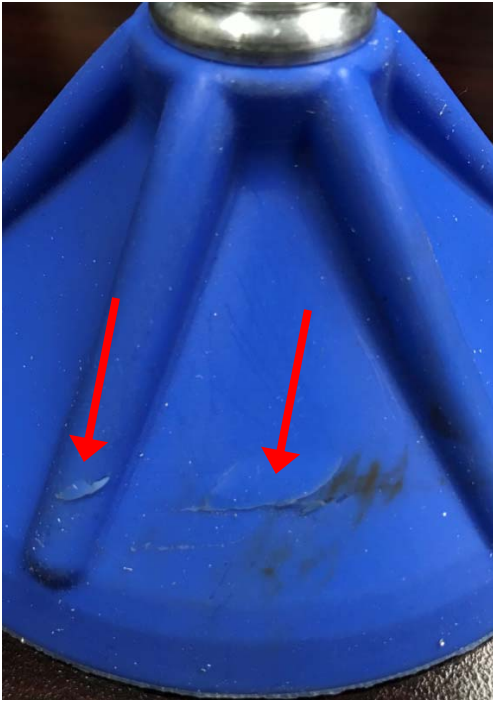
Figure 1. – Cuts into the cone.

2. With the outlet gate removed from the car, visually inspect all of the blue aerator cones for any signs of damage. Cuts or tears on any surfaces of the aerator cone are not allowed. See figures 1 through 3 for examples of possible aerator cone conditions that would require replacement. See figure 4 for an example of an aerator cone in perfect condition.

3. If an aerator cone requires replacement, loosen and remove the 3/8" hex bolt with a 9/16" ratchet. The hex bolt and aerator cone assembly should be discarded and not reused.

4. A new aerator assembly can be placed over the mounting hole and the new hex bolt should be hand threaded to begin engagement.
5. While pressing down on the aerator cone, a ratchet can be used to tighten the hex bolt until the head of the hex bolt just contacts the aluminum insert of the aerator cone.

6. A torque wrench with 9/16" socket should be used for the final tightening of the hex bolt. The acceptable torque range for the aerator cone is 25-30 ft-lbs.

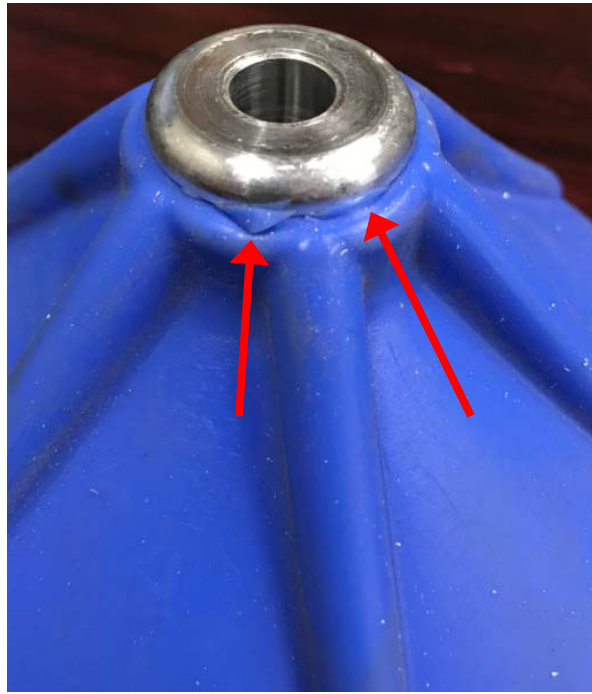
Figure 2. – Cone top not properly seated under aluminum insert bushing.

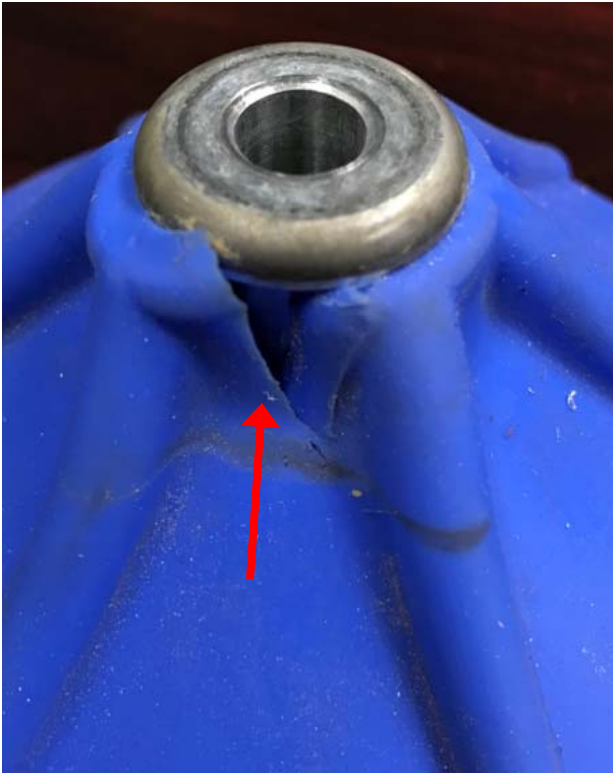
Figure 3. – Rips and tears in cone.

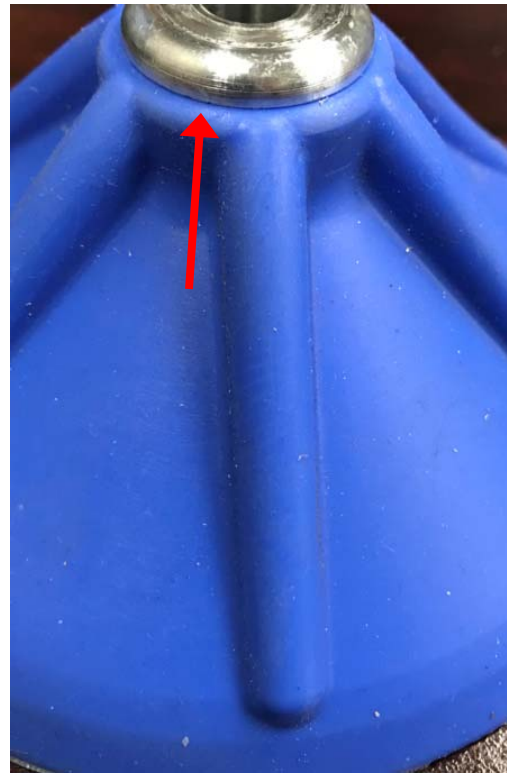
Figure 4. – A perfect cone with no cuts or tears. The cone top is also perfectly seated under the aluminum.
